CASE HISTORY :- CASTLE GARAGE, WHITWICK, LEICESTERSHIRE

ARCHITECT	HOWARD WARD ASSOCIATES
CONTRACTOR	McCANE CONSTRUCTION
CONSTRUCTION	2002
GABION WALL DESIGN	HY-TEN GABION SOLUTIONS

CASE HISTORY :- HARBOURNE, GOLF CLUB, BIRMINGHAM

ENGINEER	UNKNOWN
CONTRACTOR	PC CONSTRUCTION
CONSTRUCTION	2003
GABION SUPPLY	HY-TEN GABION SOLUTIONS

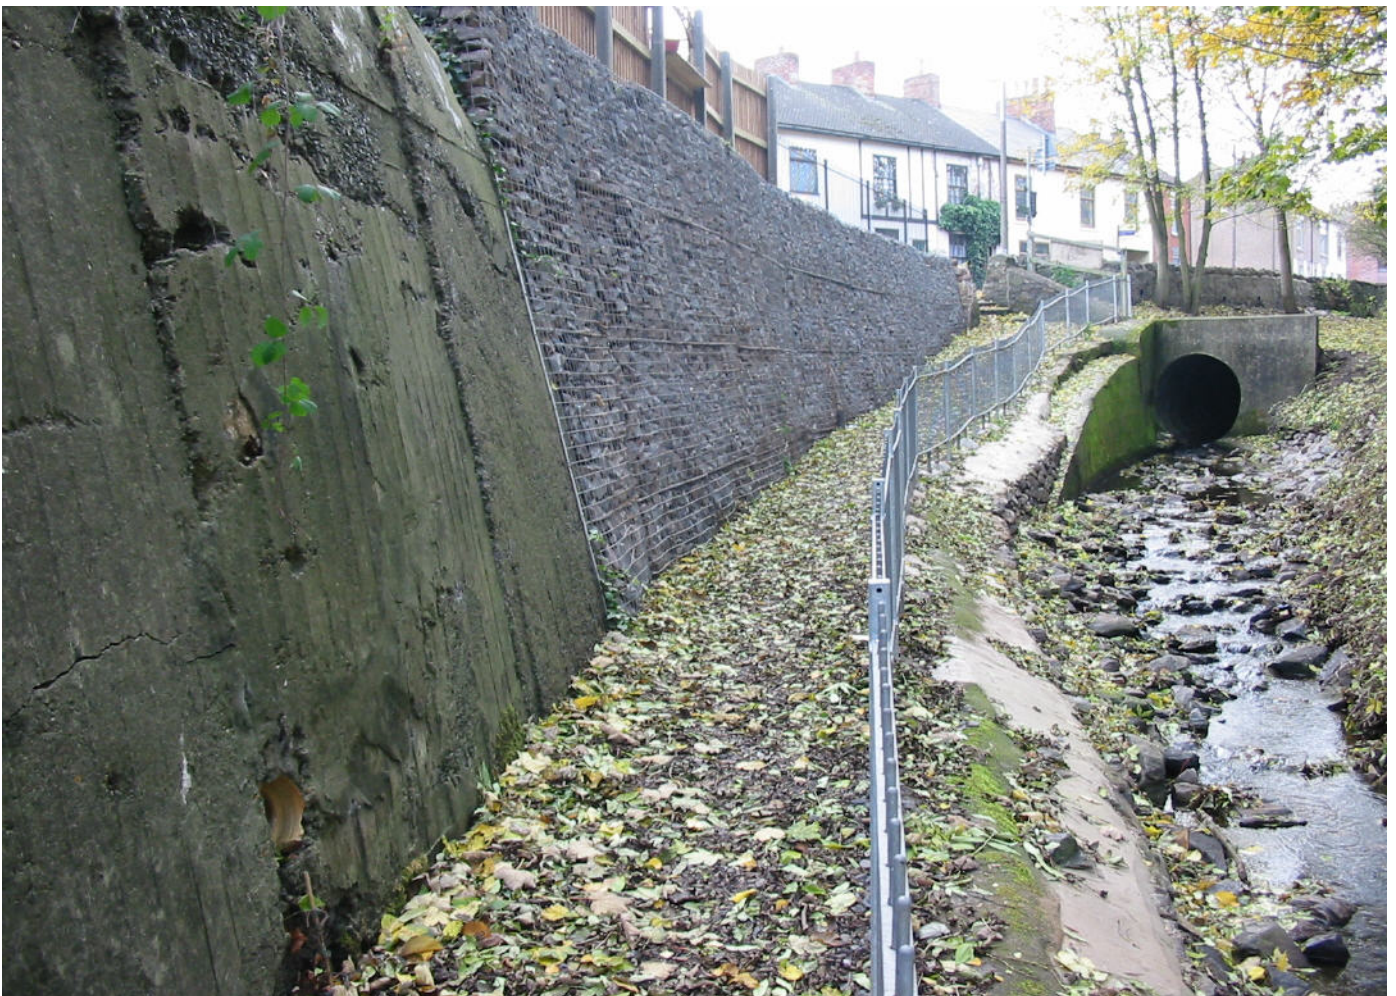
A new gabion wall was constructed after the original structure was washed away by flood Water from the adjacent road. The flood also undermined an extension to the adjacent building which was rebuilt on piled footings.

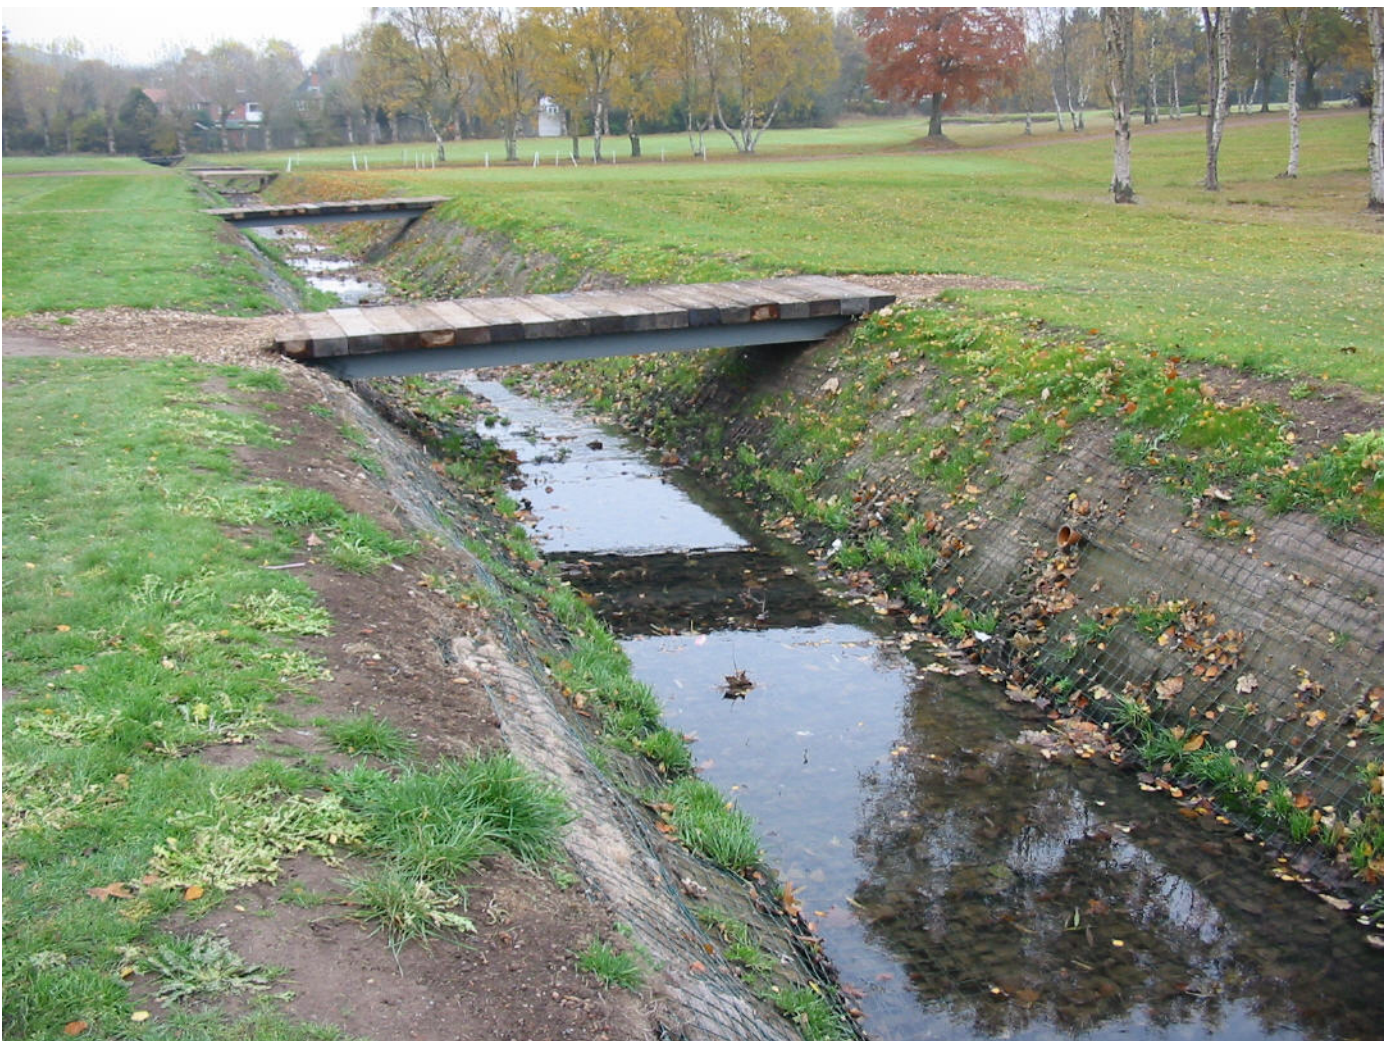
Reinstatement to an existing water course on the golf course was carried out with 300mm deep gabion mattress channel lining. The gabions supplied were Green PVC-Zinc mesh 76.2mm x76.2mm x 2.7mm filled on site with rock fill to the bed of the water course and for the banks a soil/rockfill mix was used with the top face lined with a bio-degradeable matting to help promote the establishment of natural vegetation.

This photograph was taken a few months after completion and the vegetation is starting to become establish.
