CASE HISTORY :- Cokenach Estates

CONTRACTOR	Smallwood Gabion Contractors
CONSTRUCTION	April 2006
GABION WALL DESIGN	HY-TEN GABION SOLUTIONS

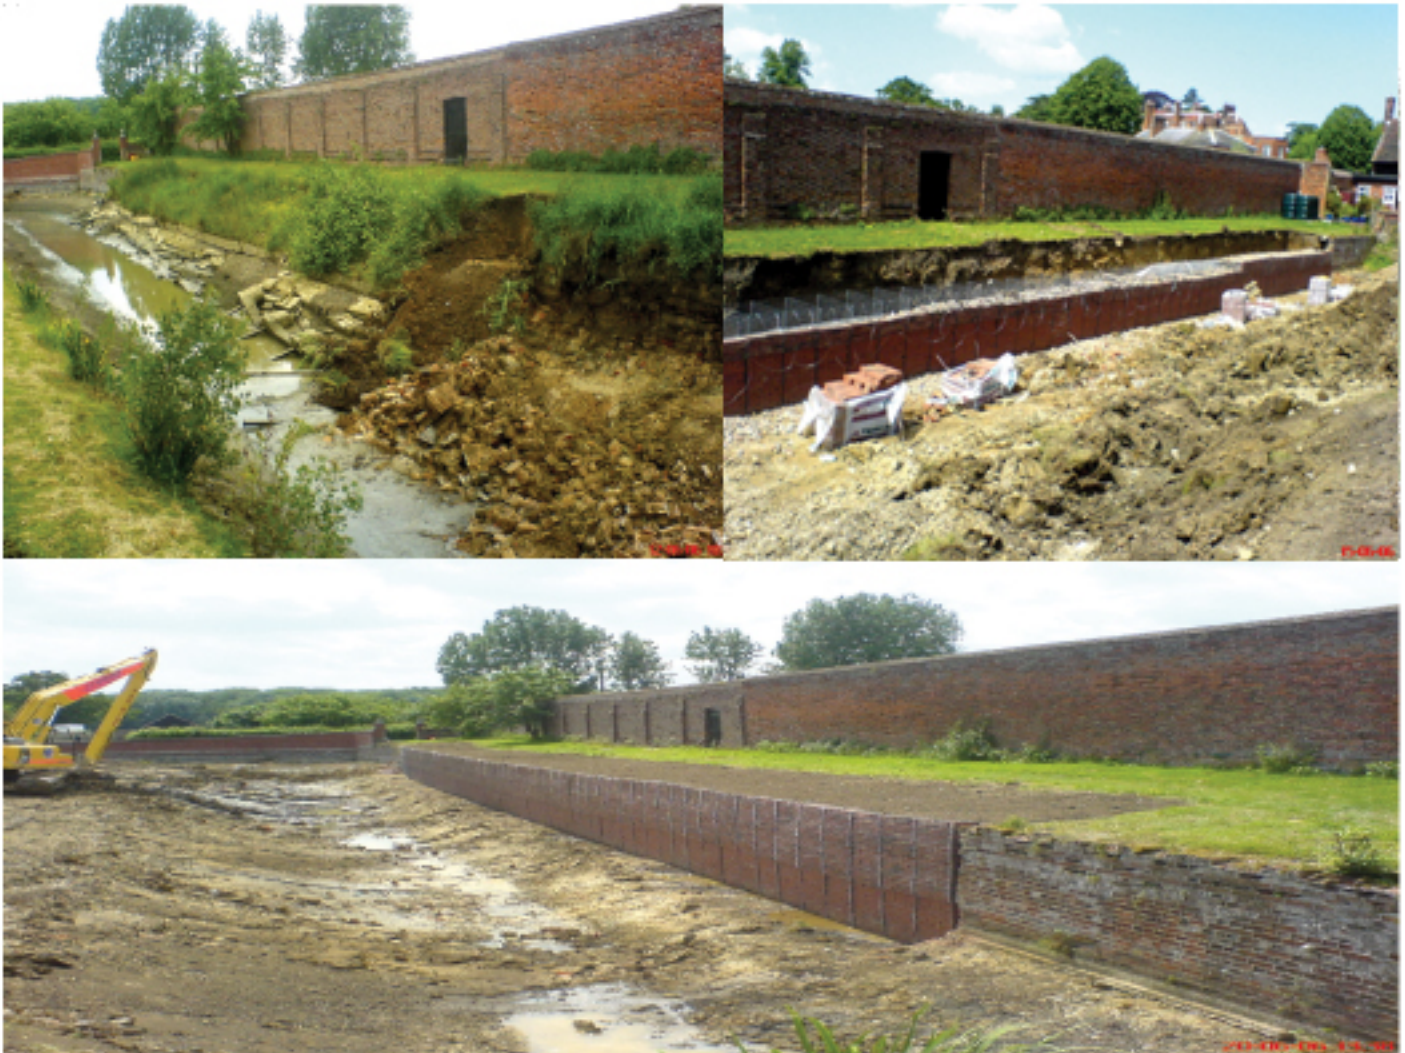
The gabion wall was designed with a flush face using the Hy-Ten gabion 700 system to ensure a superior quality of construction.

The gabions were filled with granular site fill behind a facing of reclaimed bricks which were from the original wall.

Following the failure of the existing moat embankment, Hy-Ten were requested by the contractor to prepare a Gabion Wall design for reinstatement.
